June 2010

**CONFIRMATORY REPORT ON THE
STRUCTURAL INTEGRITY
OF
CHALLENGER 2 MBT & DTT HULL**

CR2 STRUCTURES

(TASK AUTHORISATION NO. FTS2/RCM/5066/024)

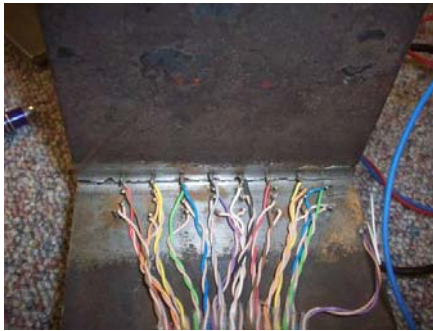
Fig 3a – Electrodes welded along crack site

four; two to measure the reference voltage (V_r) and two across the crack to measure crack voltage V_c . In order to measure a crack several centimetres in length, it is necessary to add further groups of electrodes as shown in Fig 3a.

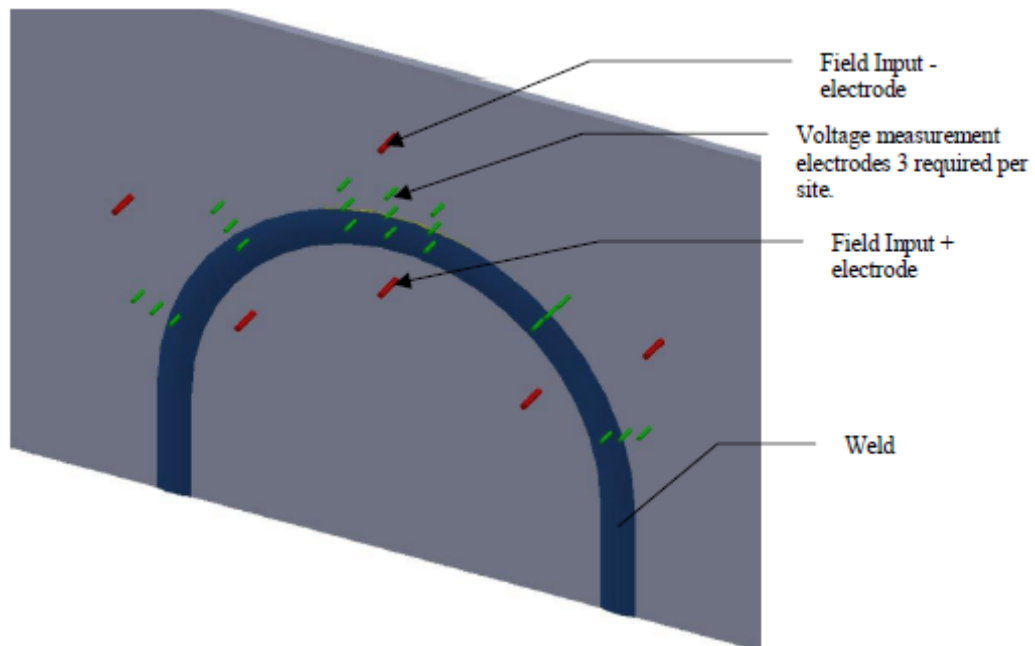
Fig 1 – Positioning of electrodes (sensors)

4.3 Cracks are usually found in the toe of the weld nearest to the parent metal (hull side plate) and start at the top of the casting and travel down both sides to a length of up to 500mm between the 9 to 3 o'clock positions. From residual section failure analysis conducted by DSTL the material gets close to yielding at a depth of 13mm for a maximum observed crack length of 500mm.

4.4 The illustration above shows the wheelstation weld (in dark blue) and the proposed position of the electrodes (sensors). It was proposed that seven crack measurement positions are used, three at roughly the 12 o'clock position where the crack is most likely to initiate and be the deepest. The other four are spread along the weld length as shown in Figure 1. The spacing between the voltage measurement electrodes will be 20mm. Thus a crack with 10mm depth will result in a doubling of voltage reading.

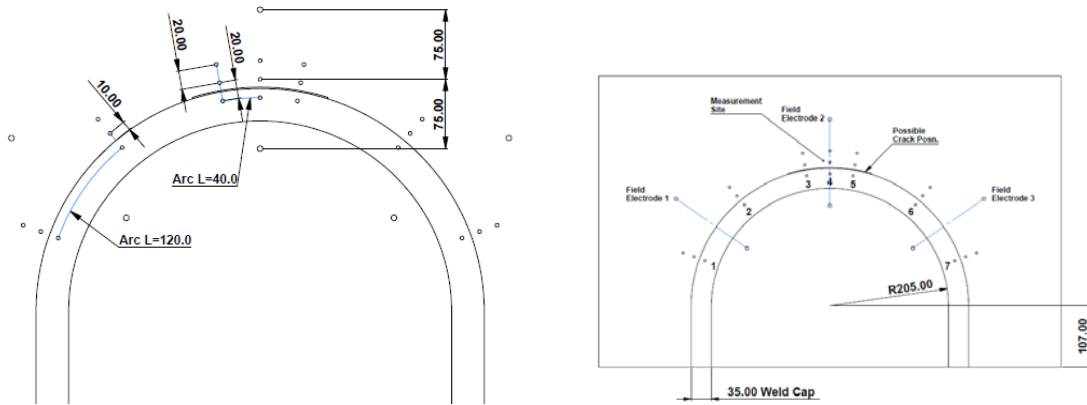
Fig 3a & 3b– Planned position of electrodes

4.6 A detailed plan of the position of the electrodes is shown in Figure 3a & b.

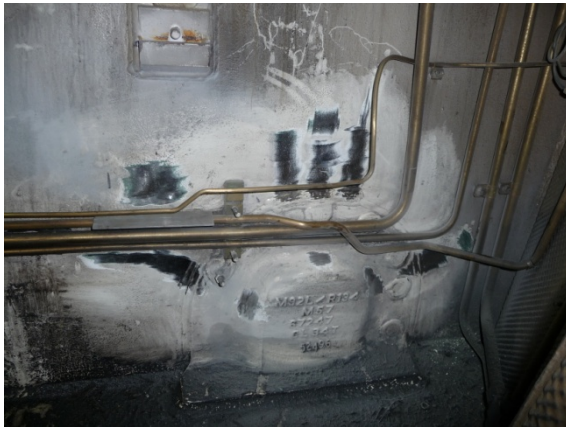
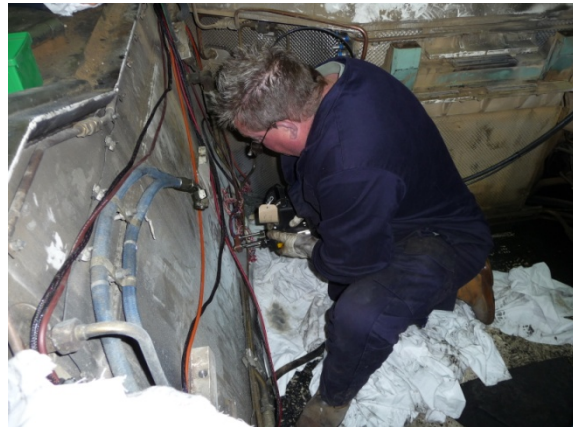
Fig 6-Wheelstation No. 5 marked up for sensors Fig 7- Electrodes (studs) being welded in place

5.2 The original plan to fix 7 sets of sensors had to be reduced to 5; 3 at the top and one at the 9 and 3 o'clock positions because of the fuel pipes. This was not a major issue as we would still be able to monitoring the important part of the weld at the top and also detect when a crack had reached the maximum tolerable length. The absence of these sensors would mean that we would not be able to monitor crack propagation quite as well during the trial period. To compensate for this a little, the two sensors either side of the top 12 o'clock sensor were moved a further 10mm apart, thereby increasing the area to be monitored at the top to 100mm wide.

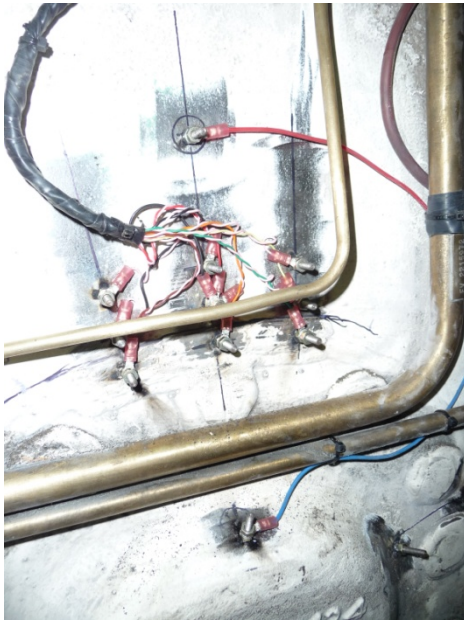
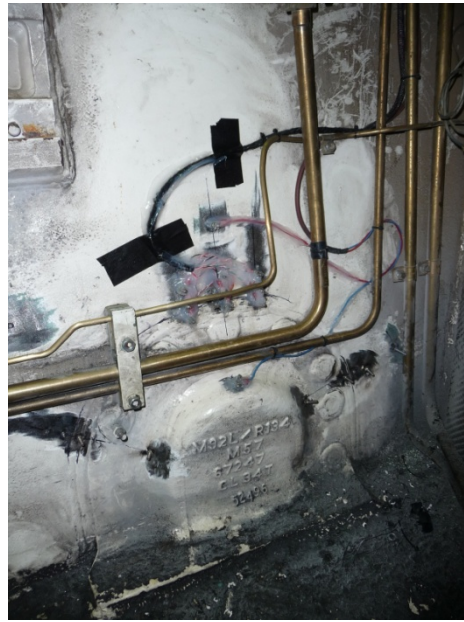
Fig 8- Shows sensors clamped to studs

5.7 The wire ends nearest the sensors had been terminated with M4 eyelet clamps and they were carefully secured in place by locking each one between two M4 nuts, as shown in Fig 8. It was important that none of the wire moved as this could affect the readings, so they were bonded down with silicon sealant. Cable ties were also employed to secure the cable run to the adjacent pipe work. If this fitment was ever formally implement in the future then a more appropriate method of securing and protecting the cable would be required.

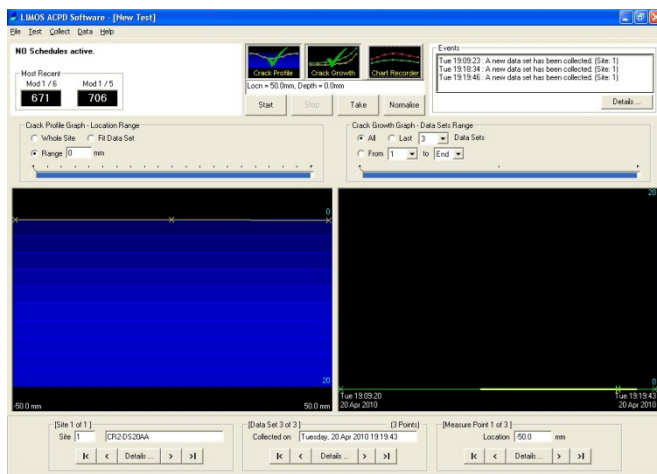
Fig 10 – LIMOS ACPD plot of rear weld on WS No. 5 Fig 11 – Illustrates a cracked sample (not CR2)

5.8 The complete installation was finally tested by TSC to ensure all of the electrical paths were good, followed by a reading of the weld on the wheelstation. Fig 8 shows the test result for the three sensors at the top of the weld casting. The plot on the left shows three points, which represent the three sensors monitoring the weld. The distance between the sensors is shown at the bottom of the graph along the 'X' axis i.e. -50, 0, 50. The 'Y' axis displays the depth of the crack. At present the trace is sitting on the zero (0mm) line. If a crack was present say between the middle sensor and the one to its right then the trace would drop down between these two points to a nominal value on the Y axis (currently set at a range of 0 to minus 20mm)
